Forensics: Genesis 1 component-mod

Darren Wershler and Ace

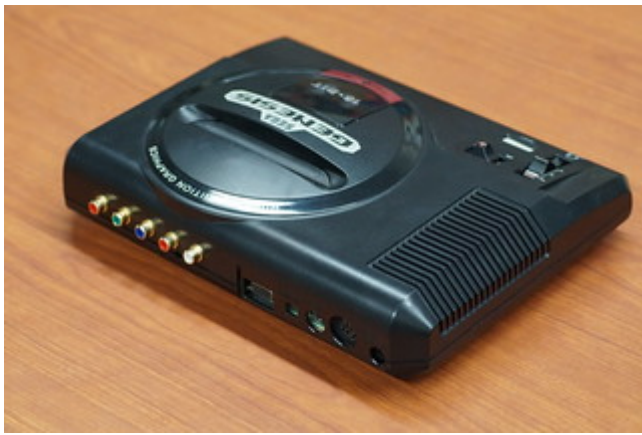
About a year and a half ago, the Depot acquired this Sega Genesis “High Definition Graphics” model 1 from a Montreal ebay seller, along with a pristine Sega CD model 2 and a base extender. What makes this particular console unusual is that it has a full set of gold-plated AV jacks added to the rear, for component video (YpBPr) and stereo sound.

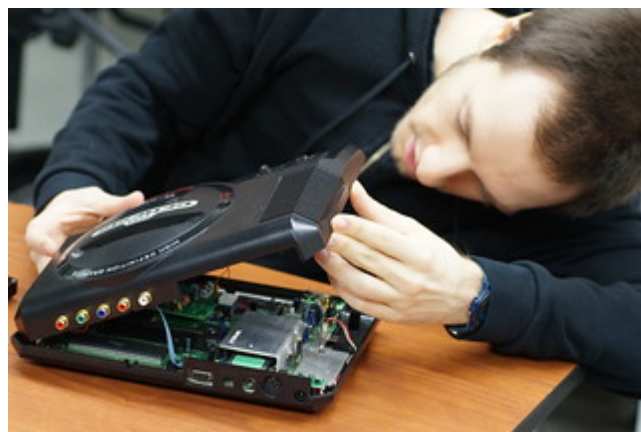
In this unit, the power LED wires were slightly squashed

against the mounting post at some point, but work fine. This is a common problem, as these wires extend across the air gap between the top shell, where the LED is mounted, and the connection wire attached to the motherboard.

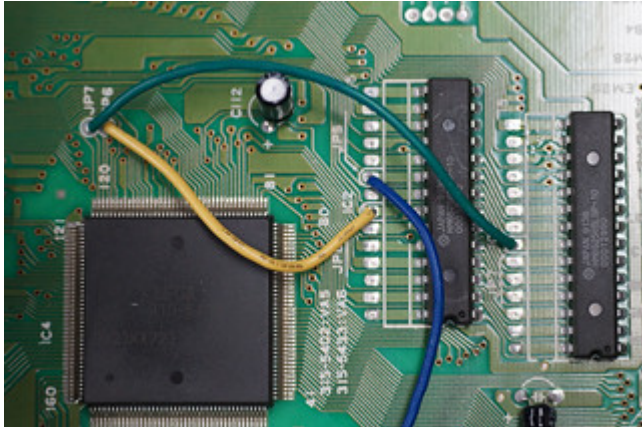
The top of the motherboard features several “bodge wires,” soldered point-to-point in order to fix factory defects on the board surface (the alternative would be making an entirely new PCB). These wires carry “enable” signals, which Sega’s custom chips generate,

to the work RAM of the Motorola 68000, the console’s main CPU. Later Genesis revisions use a single 16-bit RAM chip, but to cut cost in earlier revisions, Sega used two 8-bit RAM chips for data from the CPU, one for the lower 8 bits, and one for the upper 8. The blue bodge wire connects to pin 20 of the lower 8 bits of RAM at IC2, which is its “chip enable” input. The yellow and green bodge wires are “output enable” for the 68000’s work RAM – the yellow for the lower 8 bits at IC2, and the green for the upper 8 at IC3.

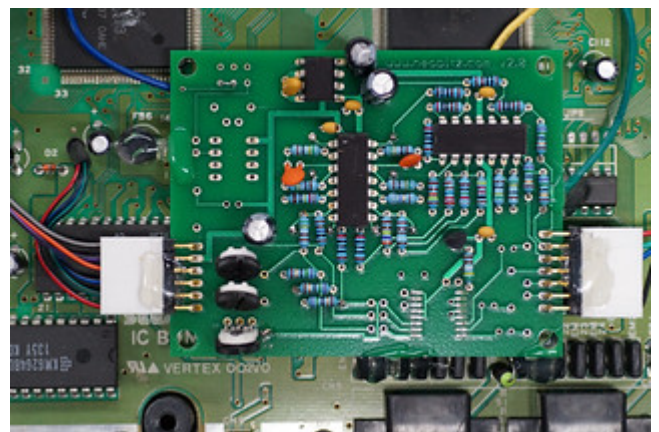
The heart of the component mod in this console is a Neobitz.com 2.0 video board, mounted with small amounts of hot-melt glue to the upper surface of the Genesis motherboard. Along with JROK’s encoder, this is one of the older RGB-to-component video encoder boards. It was made by JM (Jeff) Kurtz, who does modding and indie game development for the Neo-Geo (most recently, Knight’s Chance). The Neobitz 2 board was designed to add component, S-video and composite video output to the

Neo-Geo. There was also a Neobitz-S board that only produced S-video. In a thread on the neo-geo.com forum archives (dated 07-26-2005, 11:06 AM), Kurtz (a moderator) wrote that "I've had a couple people tell me they have used it in a Genesis."

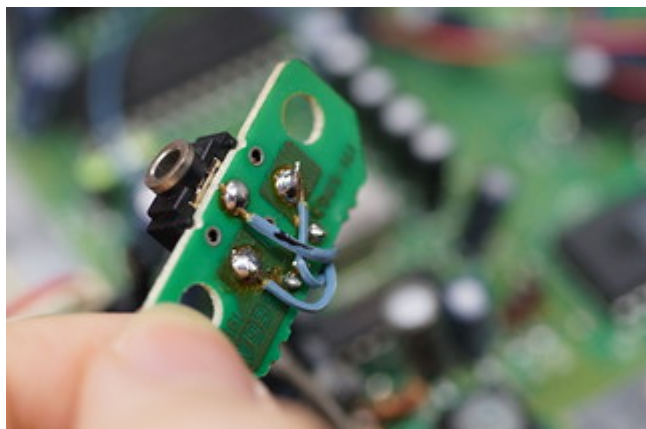
The Neobitz board has three pots (potentiometers) for separate adjustment of the red, green and blue (RGB) channels ... which his helpful, as the output from the system currently has a green cast on cartridge games and a blue cast on Sega CD games.

The audio connection for the Neobitz board has been tapped from the headphone out. Again, this is an older modding technique, which predates the recent practice of pulling audio from the pre-amp on the CXA1034 chip (Sony's headphone amp chip).

The video encoder on the Neobitz board (which produced S-Video and composite video) has been desoldered and removed. As a result, some solder traces on the board show visible signs of damage from the this process.

oddly, it will accept 240p over HDMI. For testing, we used an *Earthworm Jim* cart. (Incidentally, this is one of the Genesis cartridges where there is an audio glitch; we will return to this during our audio-modding project) and *Sonic CD*. There was a visible green cast on the cartridge game, and blue cast on the CD game. We are waiting on the arrival of an oscilloscope so we can adjust the pots with the help of Artemio's 240P Test Suite.

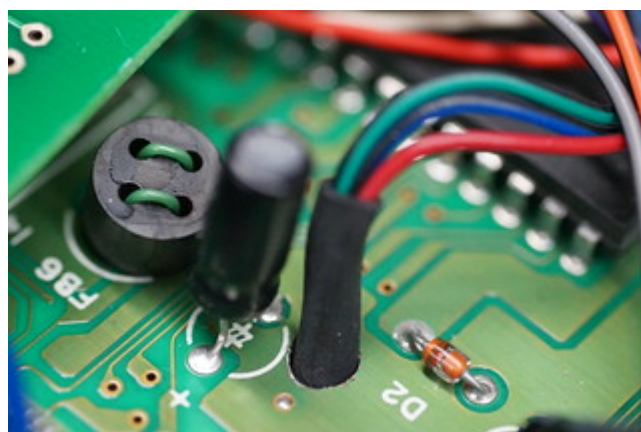
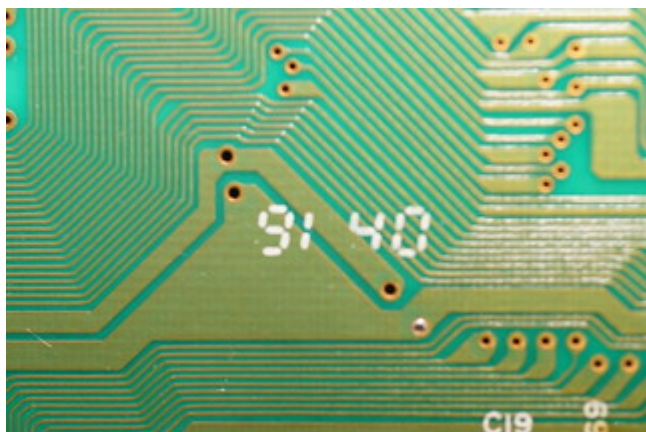
A hole has been drilled through the motherboard to run the RGB wires from the underside; the wires were protected from abrading against the edges of the hole with heat shrink. This is an odd decision, because the RGB could have been pulled straight from the RGB output pins on the video encoder on top of the board. Because this choice could potentially affect the signal, we decided to remove the motherboard to inspect the underside. One screw, which should have been beside the audio jack, was out of place.

The underside of the motherboard is stamped "91 40", indicating it was manufactured in the 40th week of 1991. This is a relatively old board for VA6, but is one of the later overall Genesis model 1 boards. What really interested us, though, was the state of those

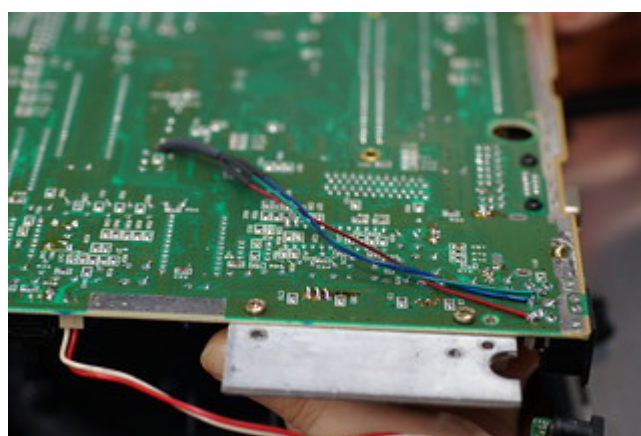
We found that the RGB wires running through the hole in the motherboard connect to the 8-pin DIN A/V output connector. The modder may have run out of wire, or short lengths of wire may have been supplied with the Neobitz board as part of the install kit, as there is a soldered and heat-shrunk connection in the middle of each of these wires.

We reattached the motherboard to the case, with all screws in correct positions, and then reattached the Neobitz board to it with 2-sided clear Gorilla Tape rather than more hot-melt glue.
